SURETRACE™ CIRCUIT TRACER

YOUR TROUBLESHOOTING SOLUTION FOR AFCI/GFCI/COMBO BREAKER PROTECTED BRANCH CIRCUITS

FINDING COMMON SPLICE ERRORS CAUSING NUISANCE TRIPPING OF AFCI/GFCI/COMBO BREAKERS

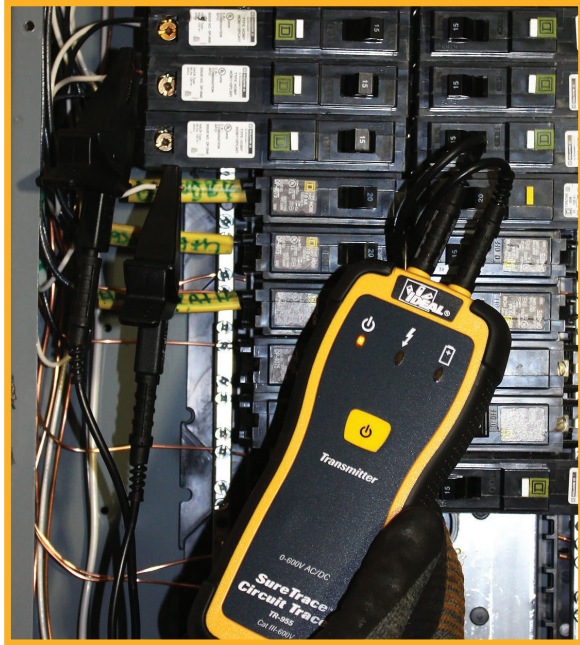
STEP 1: ATTACH CLIPS

Attach Transmitter alligator clips to the affected breaker neutrals. (The two neutrals of the AFCI/GFCI/ Combo Breakers that are nuisance tripping).

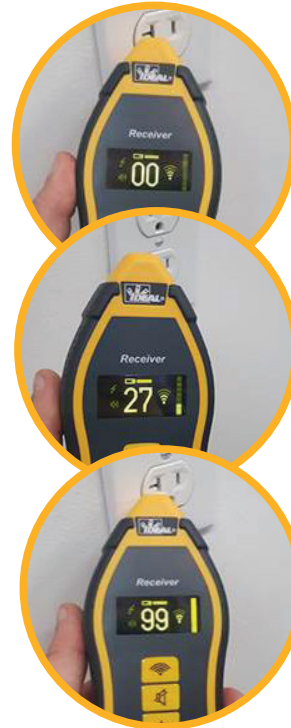
STEP 2: SCAN

Scan each electrical location (switch, outlet, light fixture, etc.), with the Receiver in the 3rd sensitivity mode setting until you identify the highest numeric reading on the Receiver.

The highest numerical value on the Receiver indicates the location of the incorrectly spliced conductors.

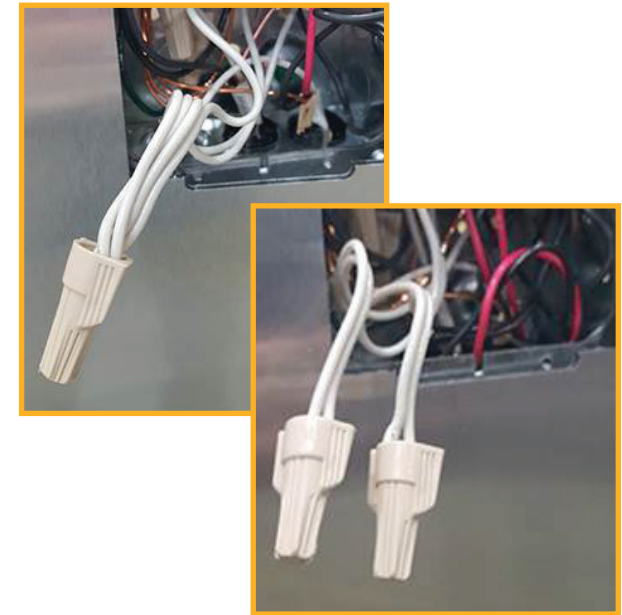
STEP 3: SEPARATE NEUTRALS

Identify the incorrect splice, separate each circuit's neutral conductors, and re-splice each neutral circuit's connections.
